BMW Airhead Oil Filter Canister Displacement: Service Practice, Load Paths, and the \$2,000 O-Ring Myth

Konrad Juethner

March 1, 2026

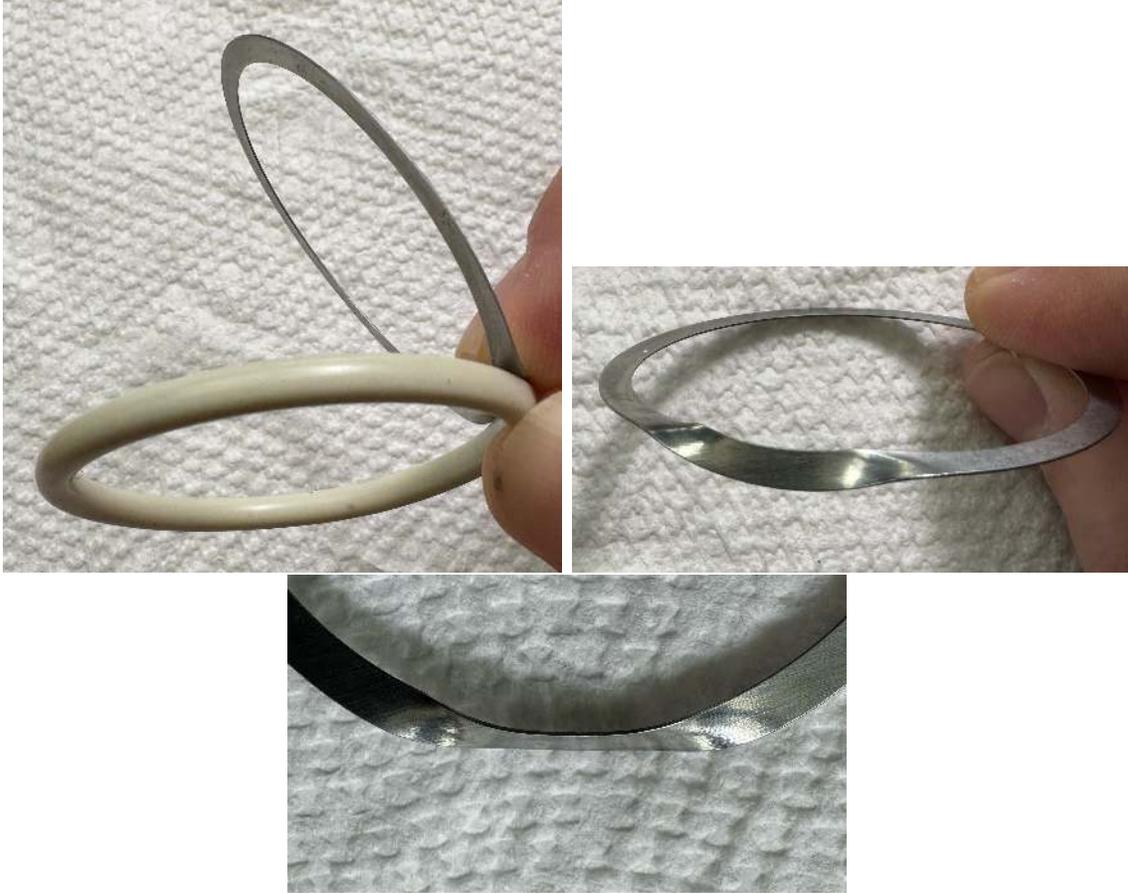
The O-ring visible in Fig. 1 appears nominal and is included primarily for reference. Its mechanical role is indirect but decisive: once local support at the canister mouth was compromised, the O-ring—effectively incompressible in volume—continued to transmit its axial preload into the seal stack. With the load path constrained by the surrounding geometry, this preload was redistributed into the unsupported portion of the shim, producing smooth local plastic bending without requiring global overload or gross misalignment. In this condition, the O-ring transitions from a compliant sealing element to an effective load-transmitting medium.

Figure 1: *O-ring and shim condition as found. The shim shows smooth, continuous plastic curvature in the region rendered unsupported by radial displacement of the canister mouth. The O-ring appears nominal and is included for reference; its contribution to the observed deformation arises from load redistribution under geometric constraint rather than from visible material distortion.*

Under these altered support conditions, the O-ring continues to transmit its preload into the seal stack, as quantified above. Because the shim is no longer uniformly supported, this force is applied over a reduced and asymmetric area, causing the unsupported portion of the shim to plastically deform and translate axially. The resulting axial motion drives the elastomer laterally into the annular gap between the canister and the crankcase face, producing the observed external oil leak.

Distinguishing rigid-body motion from localized yielding is difficult *in situ*; however, both mechanisms are consistent with the observed seal extrusion shown in Fig. 1. The demonstrated ability to re-center the canister (Fig. 2) strongly supports a lightly retained, non-heroic press-fit

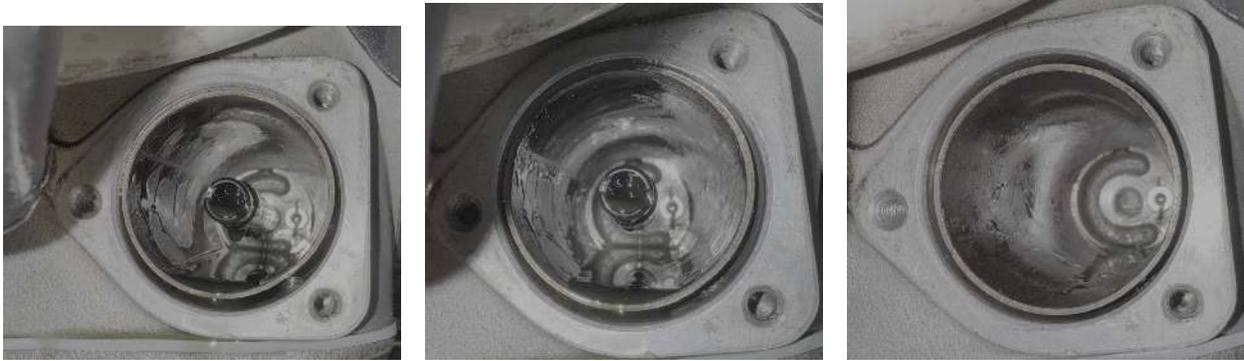
The mechanical response of the canister to this interference is documented in Fig. 2(a–c). After removal of the fastener, partial elastic spring-back was observed, but the canister did not fully re-center on its own. Deliberate mechanical re-centering at the mouth was required to restore alignment, indicating that the dominant response was rigid-body motion rather than purely elastic deformation.

Because the canister passes through the proximal crankcase wall with radial clearance and is constrained only at a distal press-fit region, radial interference at the mouth produces local lateral displacement and slight angular rotation of the canister, effectively pivoting about the distal bore. This motion does not primarily unload the O-ring; instead, it disrupts the axial backing normally provided to the thin metal shim at the canister mouth.

(a) Localized deformation identified (b) Fastener removed as first corrective action (c) Canister mechanically re-centered by controlled levering

Figure 2: *Canister displacement and recovery sequence, demonstrating dominant rigid-body motion about the distal press-fit region. (a) Localized deformation at the canister mouth caused by unintended radial jacking. Note the bolt protrusion visible in the lower-right quadrant (near the 5 o'clock position). (b) After fastener removal, partial elastic spring-back occurs, but full self-centering does not occur without an applied corrective moment. (c) Deliberate mechanical re-centering at the mouth restores nominal alignment of the canister relative to the crankcase bore. The central PIPE was removed at this stage to provide clearance for controlled levering without interference.*

The immediate mechanical issue was resolved by re-centering the canister, a field-normal repair consistent with long-standing independent service practice. Nominal alignment was restored, and the system could have been reassembled and returned to service, as illustrated in Fig. 2. In many cases, this outcome would represent a reasonable and sufficient repair.

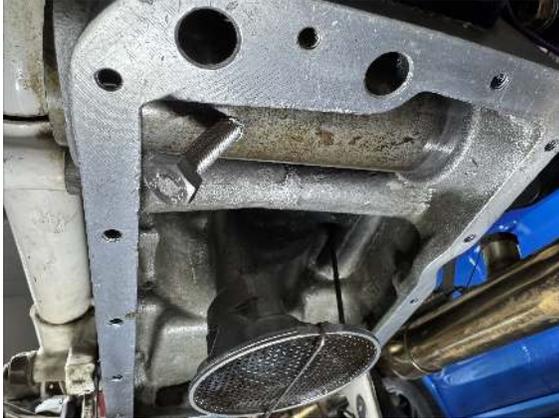
(a) Localized canister wall deformation during drive-out tapping. Repeated tapping blows applied at the bolt head produce unavoidable plastic deformation and bolt rotation in the thin wall.

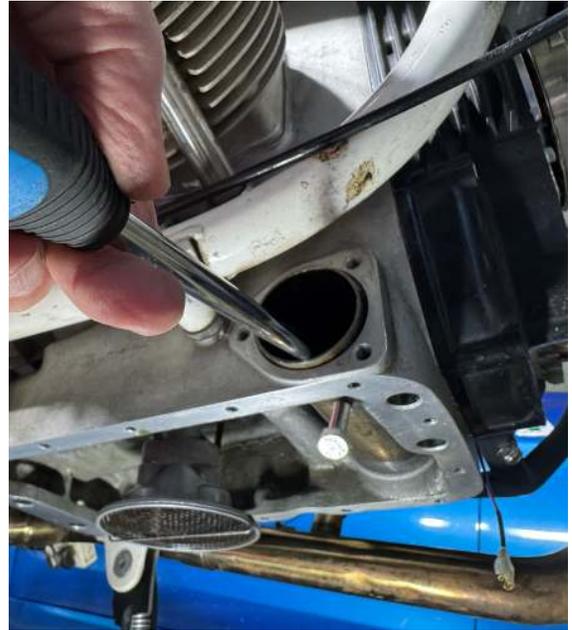
(b) Counter-torque applied to maintain axial alignment and prevent bore damage.

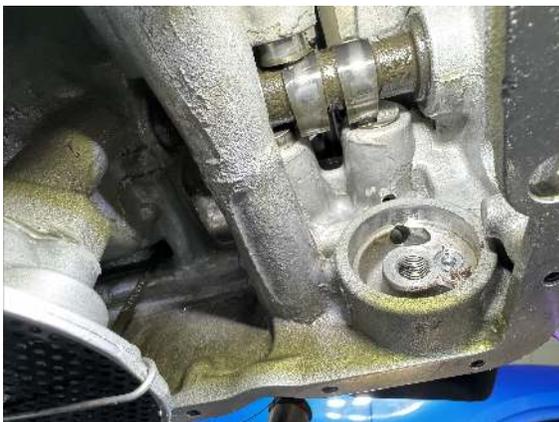
(c) Canister removed after controlled tapping sequence.

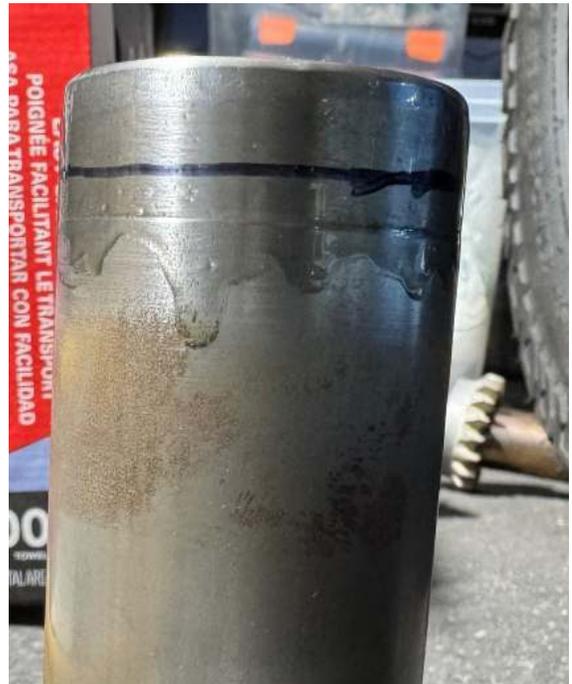
(d) Replacement canister distal end cleaned and lightly oiled prior to insertion. Note the traced insertion depth check line.

- Final depth control was achieved through direct measurement by transferring the wear mark from the original canister onto the replacement canister (Fig. 3d), and tapping the replacement canister into the bore until this reference mark was reached (Fig. 3g). This approach leverages the confirmed axial equivalence of the original and replacement canisters, with any residual variation accommodated using external shims.

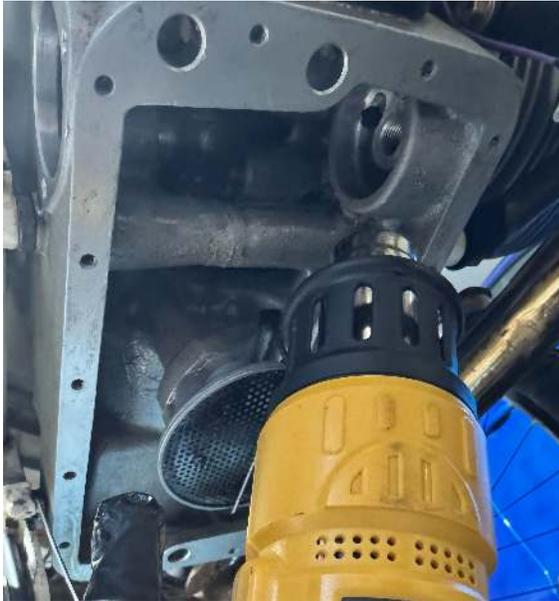
(e) Crankcase warmed with heat gun to reduce insertion force via differential expansion.

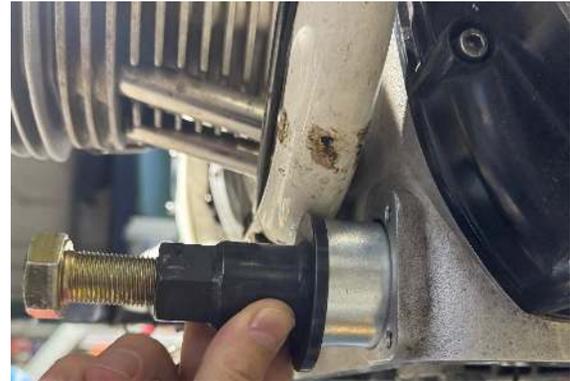
(f) Temporary axial driver assembled from available engine tools.

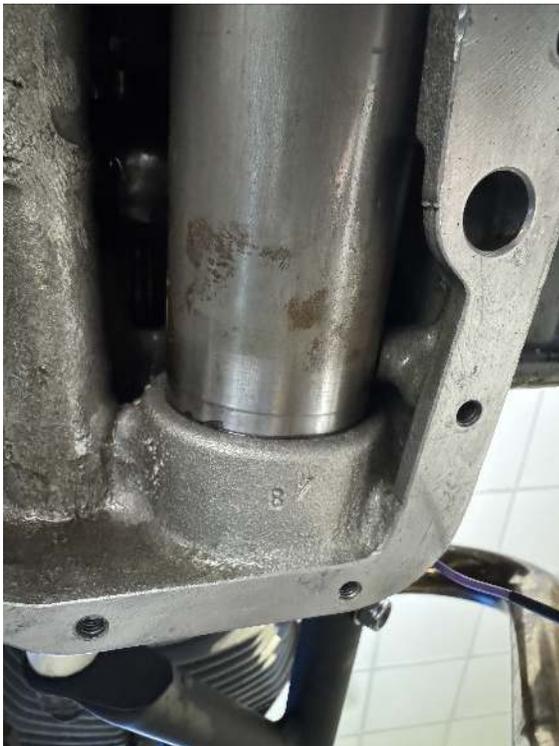
(g) Final installed position relative to the reference depth mark.

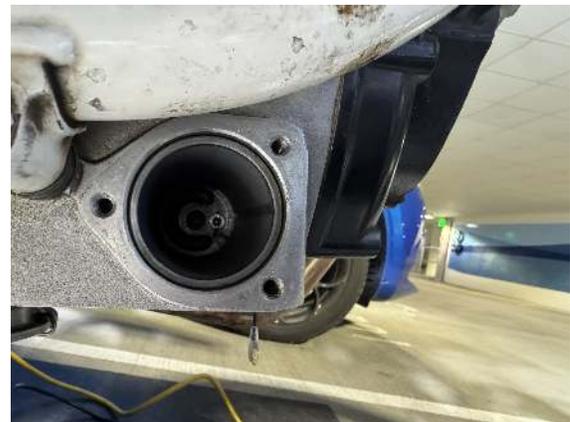
(h) View into installed canister showing improved concentricity and enhanced passive self-centering relative to the removed canister.
