BMW Airhead Oil Filter Canister Displacement: Service Practice, Load Paths, and the \$2,000 O-Ring Myth

Custom Konrad

January 11, 2026

Abstract

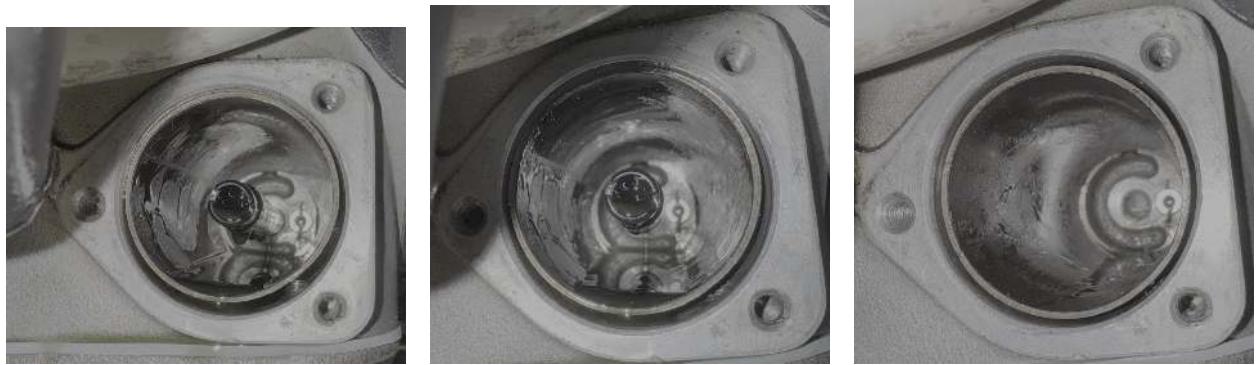
Further inspection identified radial interference between the oil filter canister and an overlong oil pan fastener located beneath the canister mouth. During installation, slight resistance was felt while tightening this fastener. This resistance was initially interpreted as normal thread engagement but is more consistently explained as the onset of lateral contact between the fastener tip and the thin-wall steel canister, introducing an unintended radial jacking load.

The mechanical response of the canister to this interference is documented in Fig. 2(a–c). After removal of the fastener, partial elastic spring-back was observed, but the canister did

(a) Localized deformation identified (b) Fastener removed as first corrective action (c) Canister mechanically re-centered by controlled levering

Figure 2: Canister displacement and recovery sequence, demonstrating dominant rigid-body motion about the distal press-fit region. (a) Localized deformation at the canister mouth caused by unintended radial jacking. Note the bolt protrusion visible in the lower-right quadrant (near the 5 o'clock position). (b) After fastener removal, partial elastic spring-back occurs, but full self-centering does not occur without an applied corrective moment. (c) Deliberate mechanical re-centering at the mouth restores nominal alignment of the canister relative to the crankcase bore. The central PIPE was removed at this stage to provide clearance for controlled levering without interference.

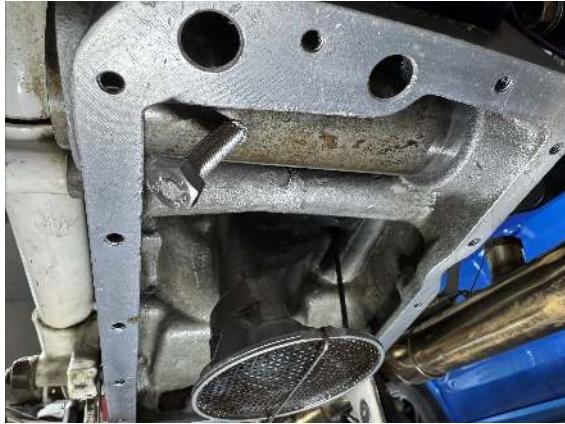
(a) Localized wall deformation during drive-out tapping. The bolt contact reaction at the canister wall was effectively radial prior to tapping. Plastic deformation and bolt rotation within the thin sheet are unavoidable.

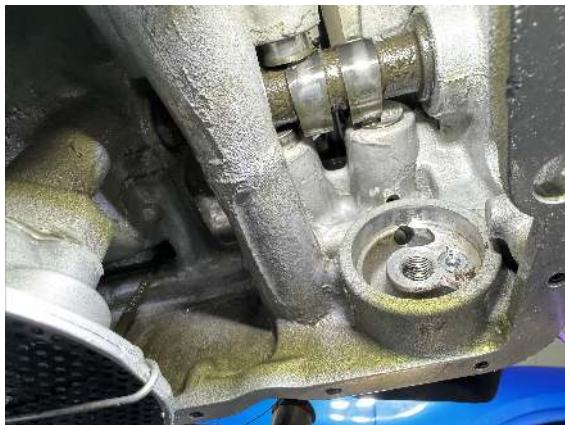
(c) Canister removed after controlled tapping se-

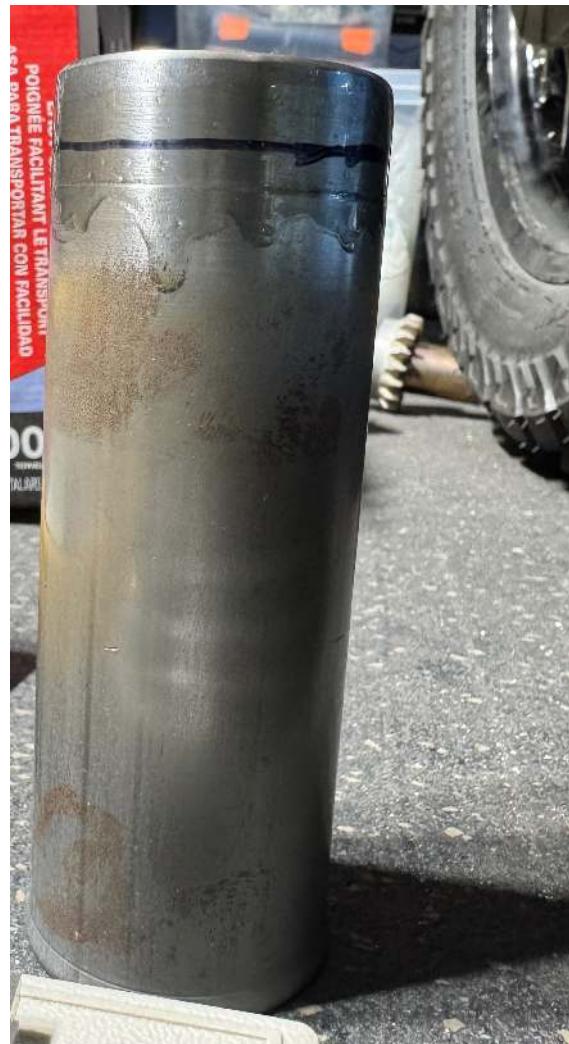
(d) Replacement canister distal end cleaned and

Prior to insertion, the distal end of the replacement canister was cleaned with gray Scotch-Brite to remove light surface oxidation and condition the surface for uniform contact during seating. The contact region was then lightly lubricated with engine oil to reduce insertion friction and mitigate the risk of galling.

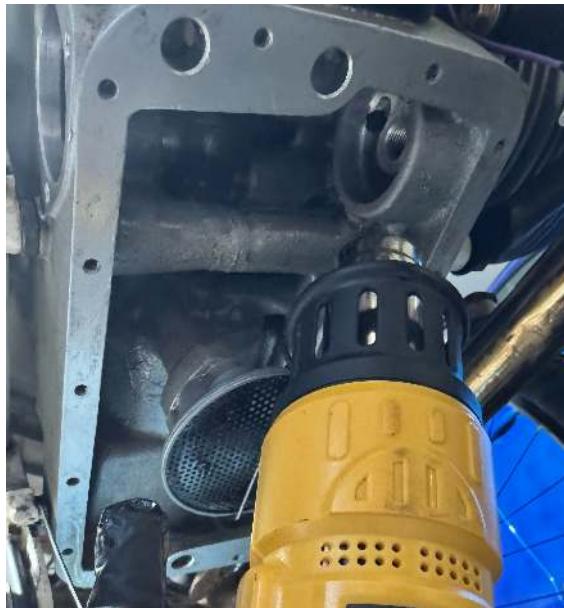
(e) Crankcase warmed with heat gun to reduce insertion force via differential expansion.

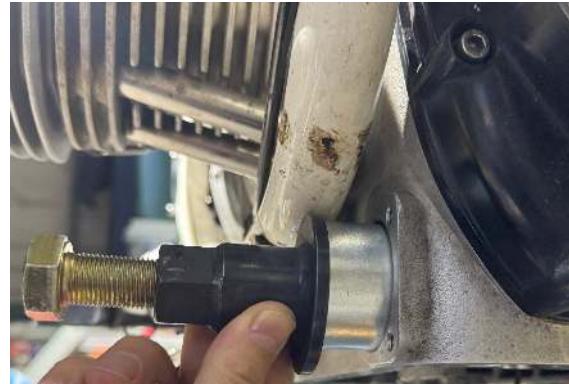
(f) Temporary axial driver assembled from available engine tools.

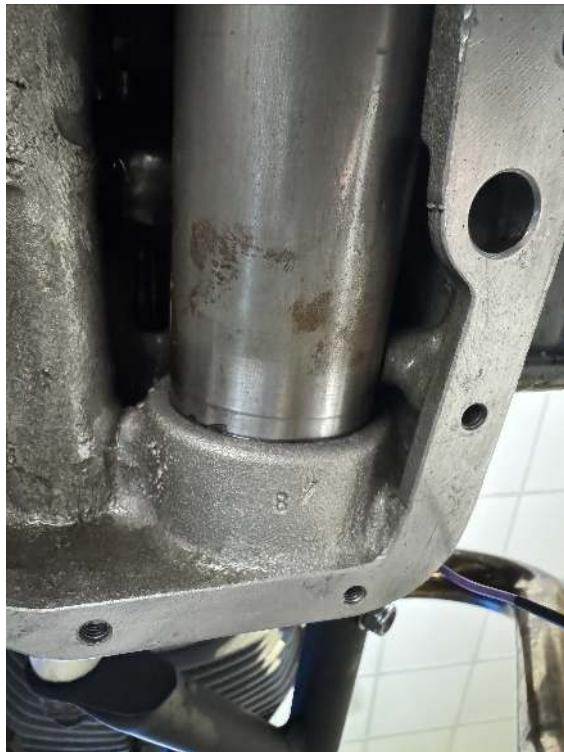
(g) Final installed position relative to the reference depth mark.

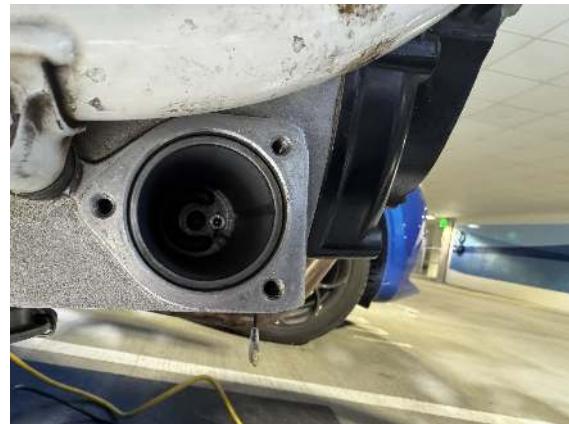
(h) View into installed canister showing improved concentricity and self-centering.

At no point during the installation was corrective re-centering required, and no evidence of asymmetric resistance or elastic spring-back was observed after seating. These observations are consistent with a clean, undistorted bore and with the mechanically more forgiving mouth geometry of the later-style canister.
